City of Centralia Rock Street Alley Bridge

Whatcom County Middle Fork Bridge

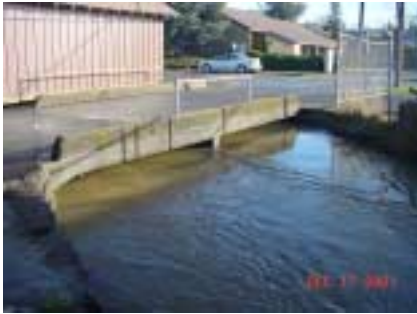
***Flow Near Max. 6" to 8" Below
Superstructure***

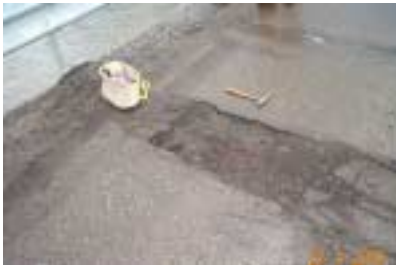
Whatcom County Middle Fork Bridge

***Cracked and Spalling Asphalt
Wearing Surface***

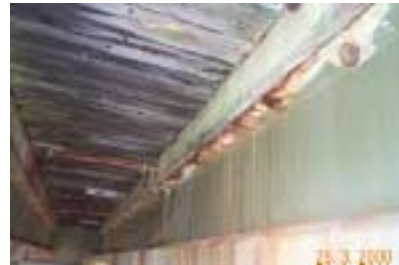
Whatcom County Middle Fork Bridge

***Beam Deterioration and Loose
Sidewalk Bolts***

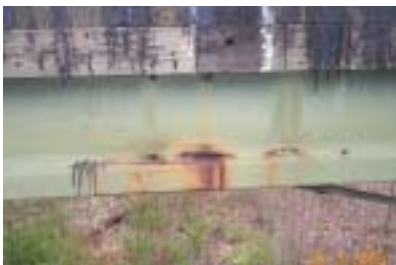
Whatcom County Middle Fork Bridge

Laminar Rust at Steel Beam

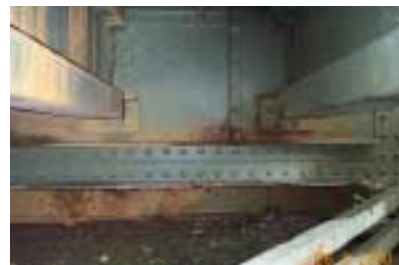
Whatcom County Middle Fork Bridge

Typical Corrosion at Floorbeams

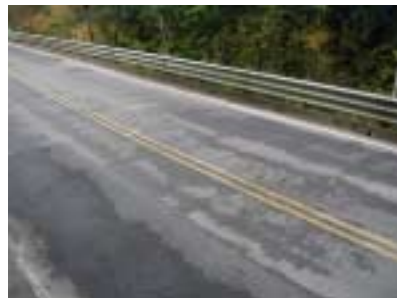
King County Ames Lake Trestle

Current Deck Condition

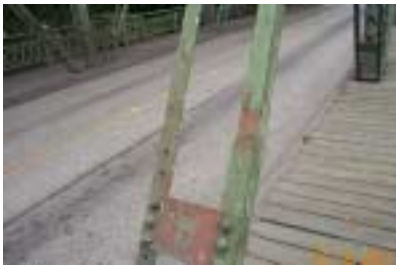
City of Sumner Stuck River Bridge

Repaired Tension Members

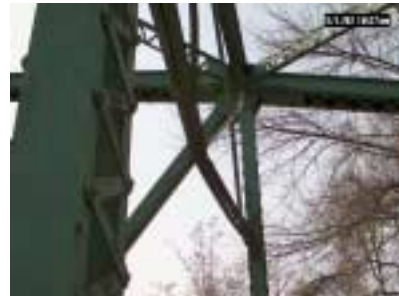
City of Sumner Stuck River Bridge

Bent Sway Bracing

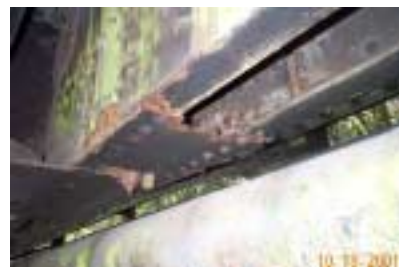
City of Sumner Stuck River Bridge

Section Loss at Bottom Plate

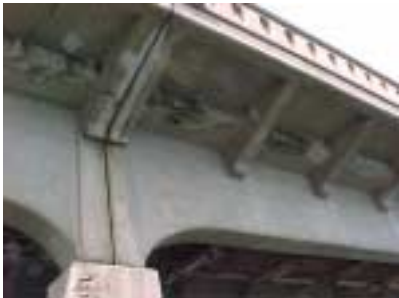
City of Chelan - Chelan River Bridge

View of Deterioration at Soffit

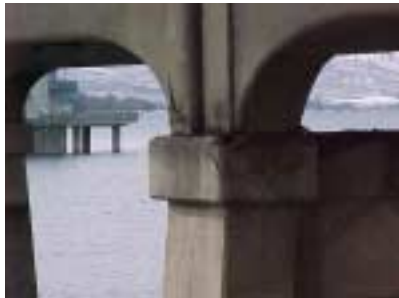
City of Chelan - Chelan River Bridge

View of Spalling Concrete at Pier

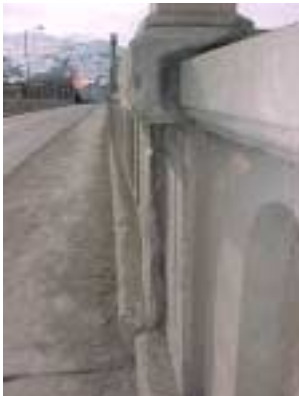
***City of Chelan
Chelan River
Bridge***

***View of
Shift in
Barrier***

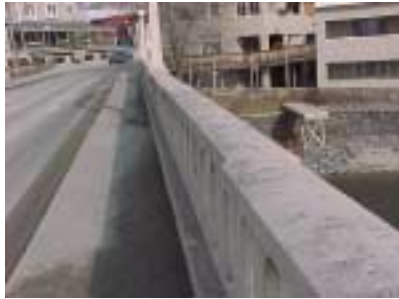
City of Chelan - Chelan River Bridge

View Showing Movement of Barrier

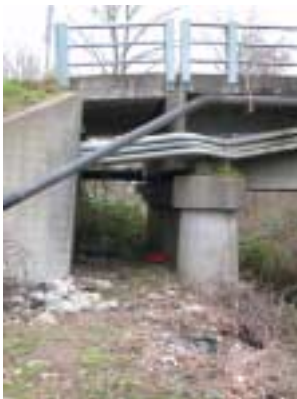
***City of Sumner
Fryar Bridge***

***View of Failing
Abutment Wall***

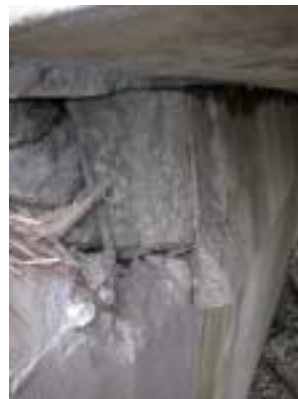
***City of Sumner
Fryar Bridge***

***Spalling of
Abutment
Wall***
